NYSTROM POND DAM CT 00457

NAUGATUCK RIVER BASIN LITCHFIELD, CONNECTICUT

PHASE I INSPECTION REPORT NATIONAL DAM INSPECTION PROGRAM

May 30, 1980

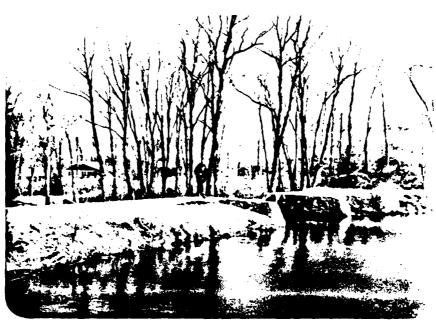
PHOTO NO. 1

UPSTREAM SLOPE OF MAIN DAM NOTE EROSION TO LEFT OF SPILLWAY

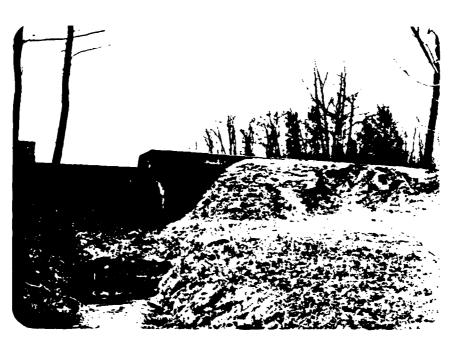
PHOTO NO. 2

DVERVIEW OF DAM FROM DOWNSTREAM, NOTE EROSION ON DOWNSTREAM SLOPE
